Seismic Assessment of New Zealand Bridges in non liquefiable soils during Canterbury earthquake sequence

Summary

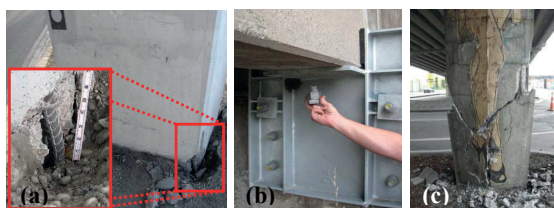
The analyses of Port Hills Overpass demonstrated that the deck's flexibility caused a high displacement demand at the central pier, resulting in bar buckling and concrete spalling (Figure 2a). Moreover the results showed that the high vertical acceleration had an important influence on the response of the structure as result of the considerable variation of the moment-curvature capacity of the piers. At Horotane Valley Overpass, being the bridge very stiff, the slope failure of the approach was the main cause of the shear rupture of the retrofit bolts (Figure 2b). With regard to Moorhouse Overpass, the collapse of the western pier was found to be caused by shear failure and secondary buckling interaction (Figure 2c). The

Figure 2: a) Buckling of reinforcing steel at the base of the central pier of Port Hills Overpass; b) Sheared bolt at the abutment retrofit of Horotane Valley Overpass; c) Shear failure of the column of Moorhouse Ave Overbridge
