## Hofplein Railway Viaduct (1900-1908):

### A Pioneering Concrete Structure that Challenges Conservation

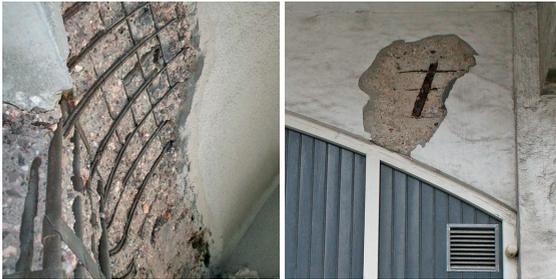
Figure 2. Examples of reinforcement bars used

A drawback was that this system could not follow the curvature of the viaduct. Therefore, then normal round reinforcement bars were used for the second construction phase. The Hofplein viaduct was described as a catalogue of viaduct reinforcement systems. The technological evolution can be seen in the different reinforcement systems adopted (Figure 2).

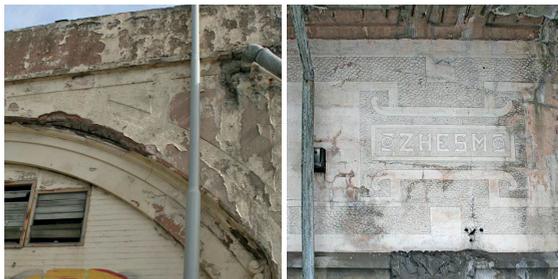
Figure 3. Details of the facade

Since then, the viaduct underwent several changes, either to adapt the function, improve the design or alter the appearance. Historic events such as a major fire during the Second World War bombardment of Rotterdam in May 1940 can be seen locally in the discoloration of the aggregates in both concrete and render. Over the years, the appearance has been altered by painting the surface white (and many other colours) and by local repairs without adapting to the texture or colour to the original surface (Figure 3). The Hofplein
