Renovation and repair of a masonry arch bridge in Thumaide, Belgium

A new windmill park is to be built in the centre of the Hainaut province in Belgium. During construction heavy transport will need to pass over a 20m span masonry arch bridge built at the beginning of the twentieth century. Currently, the spandrel walls have deformed significantly due to the pressure of the backfill. The spandrel walls and the arch show cracks and locally bricks are missing. The bridge, that crosses the RaVel (a network for cycling in the Walloon region), therefore needed a well-considered renovation to guarantee the safety of cyclists passing under the bridge. Also verification was required for the exceptional transport during construction of the wind mill park. This paper will discuss in detail how the different analysis models and strategies complemented each other, and helped convince the client to restore rather than demolish this masonry arch bridge.

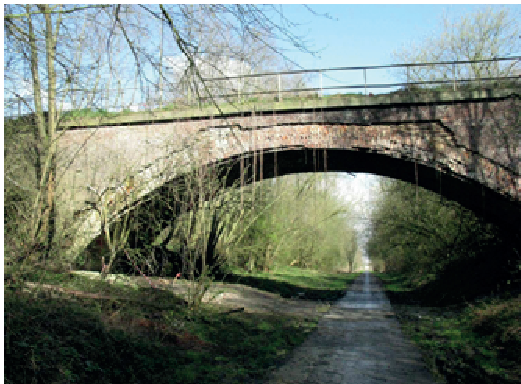
Figure 1: State of the bridge before renovation
