## The Refurbishing of the Nibelungen Bridge Worms, Germany

**Eberhard PELKE**  
Bridge Engineer

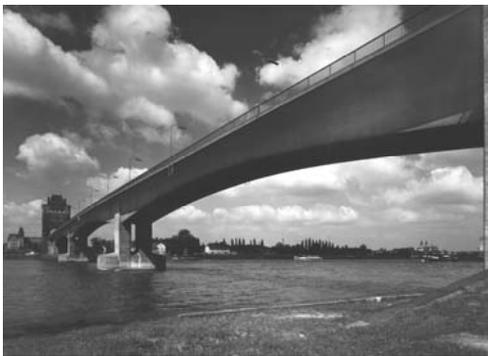
Fig. 1: Nibelungen Bridge Worms, 1953

If the Nibelungen Bridge (Fig. 1), opened on traffic in 1953, is forced into the corset of present-day technical regulations, then it loses its adequate load-bearing capacity. However, if one follows Finsterwalder's ingenious design idea of 1930 and enriches it with the ideal of fully prestressing, a careful strengthening will result with just a few external tendons laid carefully inside the two hollow boxes and an allowance for shear approach that will enable the structure to cope with today's live loads. Apart from the replacement of the tiebacks in one land pier, the further defects are due to the greatly changed, aggressive environmental conditions and the effect of de-icing salt that could not be foreseen in 1953.
